APRIL 1967
REPORT SM-49105-Q3

STRESS CORROSION CRACKING OF TITANIUM ALLOYS AT AMBIENT TEMPERATURE IN AQUEOUS SOLUTIONS

PROGRESS REPORT FOR PERIOD
JANUARY, FEBRUARY AND MARCH 1967
UNDER CONTRACT NAS 7-488

ASTROPOWER LABORATORY
2121 CAMPUS DRIVE • NEWPORT BEACH, CALIFORNIA

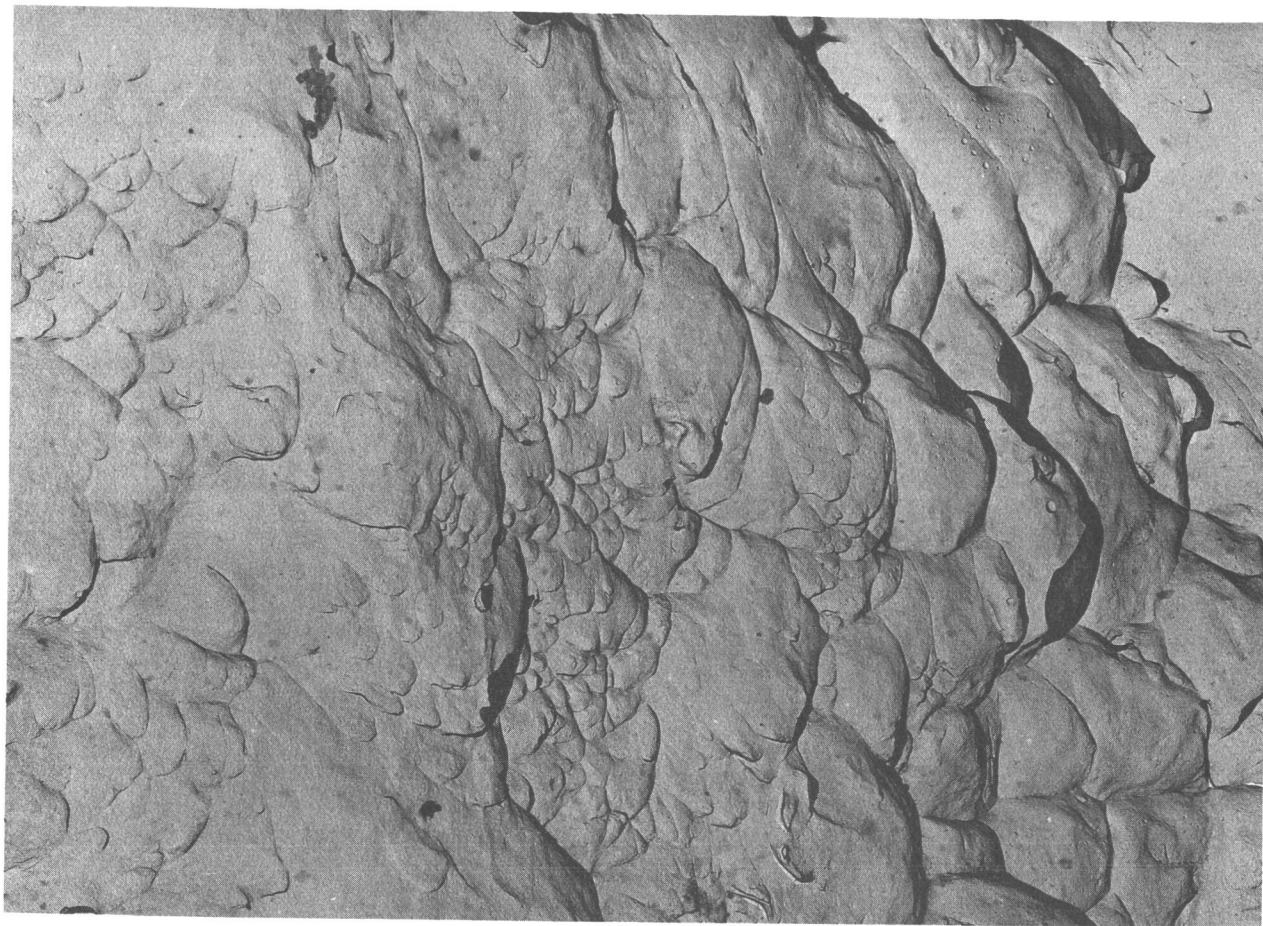
Figure 8. Electron Fractograph of Beta Alloy Ti-13V-11Cr-3Al Fractured in Air. Note dimple rupture. Magnification 7,500X.

Figure 8 shows a two-stage Cr-C replica of an all-beta type alloy (Ti-13V-11Cr-3Al) notched specimen failed under static stress in air. Similar microstructure was noted in samples fractured in distilled water and salt solution. The fracture face is virtually all dimpled structure, indicative of ductile failure.

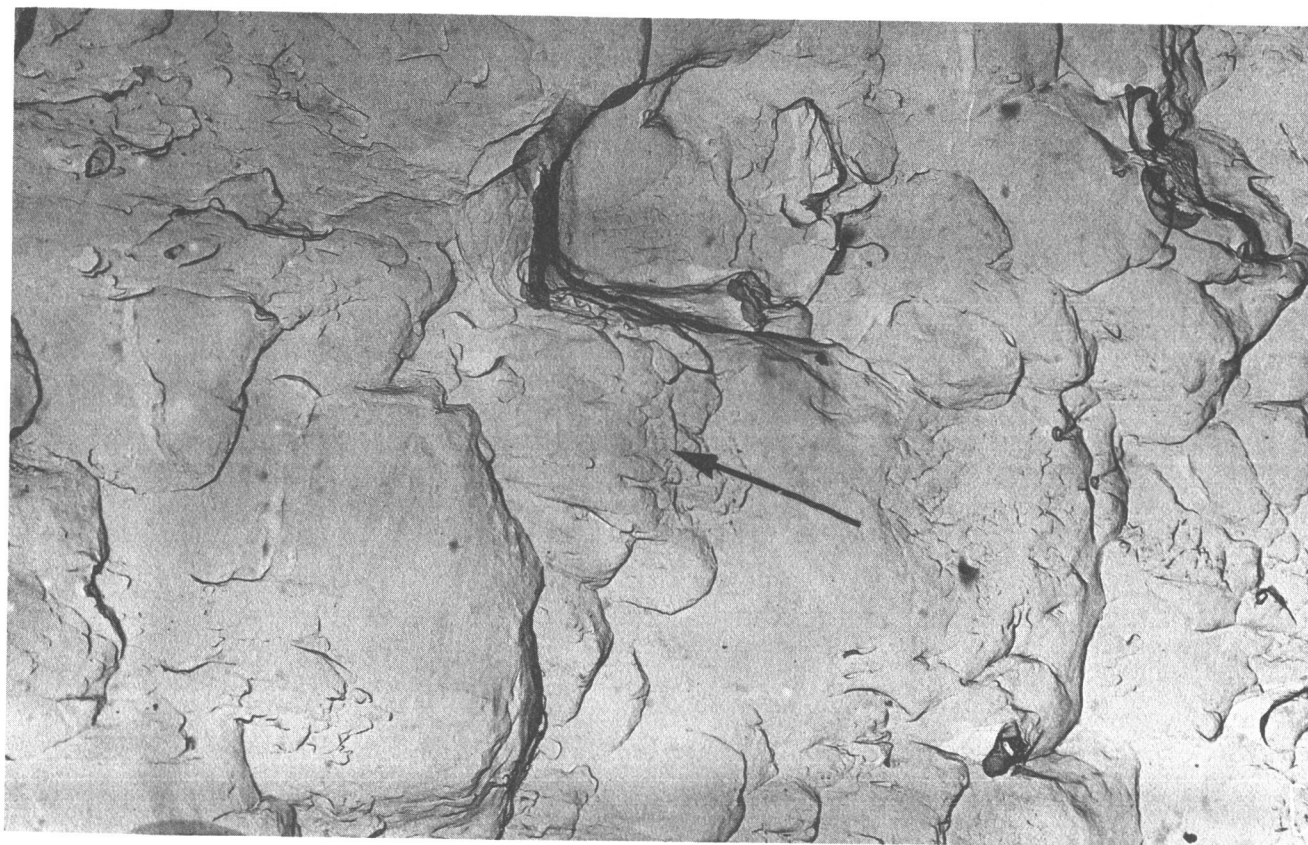
Figure 9. Electron Fractograph of an Alpha-Beta Alloy Ti-6Al-4V Fractured in Air. Note dimple rupture. Magnification 7,500X.

Figure 9 shows the fracture face of an alpha-beta alloy, Ti-6Al-4V, fractured in stress cracking in air. The fracture face exhibits ductile dimpled structure virtually throughout the surface, with some intergranular fracture facets. Figure 10 is the fractured face in stress corrosion in salt solution. The surface exhibits mixtures of cleavage and ductile regions. The cleavage areas (arrow A) are identified by river markings. The ductile areas (arrow B) are characterized by large dimples with deformation markings or serpentine glide and ripples on the surface.⁽⁶⁾
